Manhole Inspection Summary

Manhole # S41AA_010MH

Inspection ☐ Is Incomplete Rating: **3) Fair**

Location Address: **800 n.eden**

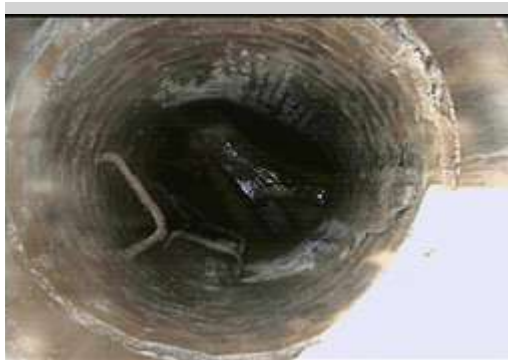
Defect 1

Count: **6** Missing: **0** ☒ **Corroded**

☒ **Evidence Of Surcharge** Depth: **2.5** (ft.) ☐ Active Surcharge Present

corroded steps; surcharge evidence

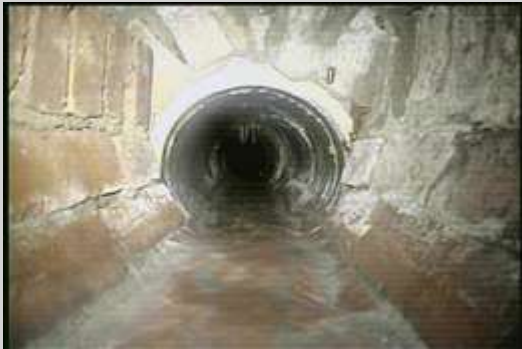
12 O'Clock Outflow

8 in. Circular Gravity Sewer
Pipe Out @ 12 O'Clock

Invert Depth: **12.25** (ft.) Flow Characteristics: **Slow**

Infiltration: **None** Pipe Seal Cond: **Unknown**

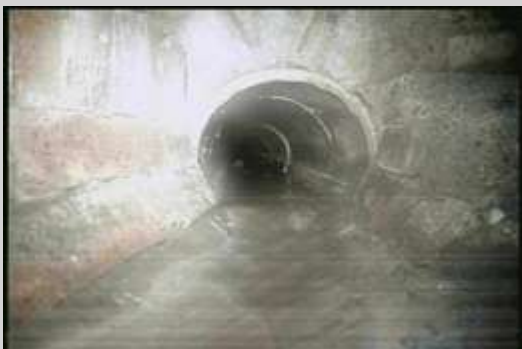
5 O'Clock Inflow

8 in. Circular Gravity Sewer
Pipe In @ 5 O'Clock

Invert Depth: **12.10** (ft.) Flow Characteristics: **Slow**

Infiltration: **None** Pipe Seal Cond: **Unknown**

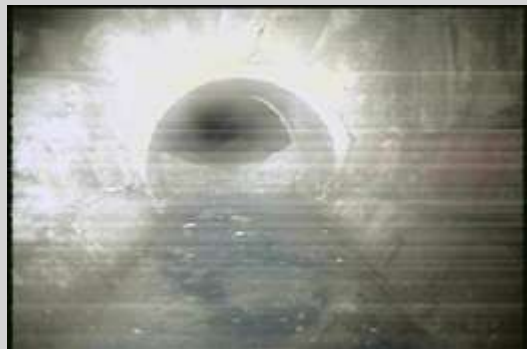
6 O'Clock Inflow

8 in. Circular Gravity Sewer
Pipe In @ 6 O'Clock

Deposits: ☐ None ☐ Mud ☒ **Sludge** ☒ **Debris** ☐ Grease

Silt Depth: **2** (in.) Deposits Extent: **Medium**
